RE: *Shantell and Edward Hayes v. Regional Enterprises, LLC et al.*

On July 18, 2023 I traveled to the home purchased by your clients, Shantell and Edward Hayes (Sometimes as “Your Clients” and “Customers”), from our client, Regional Enterprises, LLC (“Regional”) for an inspection in Ethel, Louisiana prior to our mediation/arbitration of your clients’ claims. Your clients purchased a 2020 Deer Valley with Serial No. DVAL1200860AB (the “Home”) from Regional d/b/a McComb Home Center, a manufactured home retailer, on May 11, 2021

At the inspection, your clients had marked the alleged defects and/or issues with red tape. This report will examine each of your clients' allegations to identify whether these are manufacturing defects, lack of completion of the trim out of the home, or other issues.

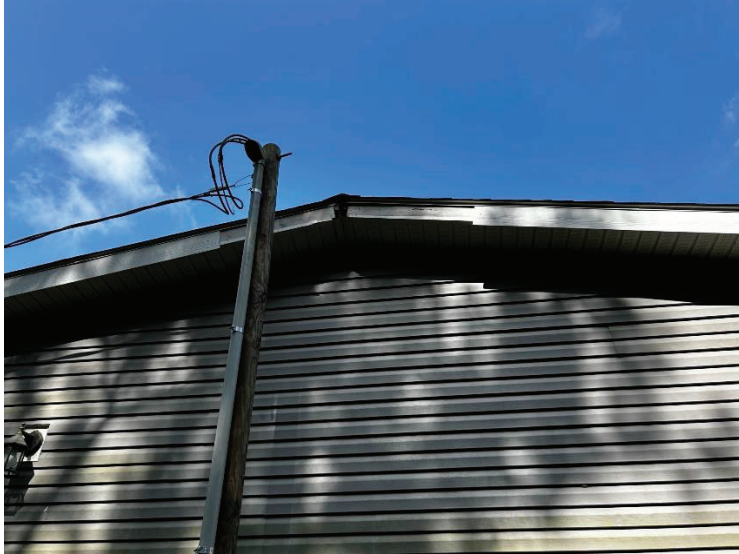
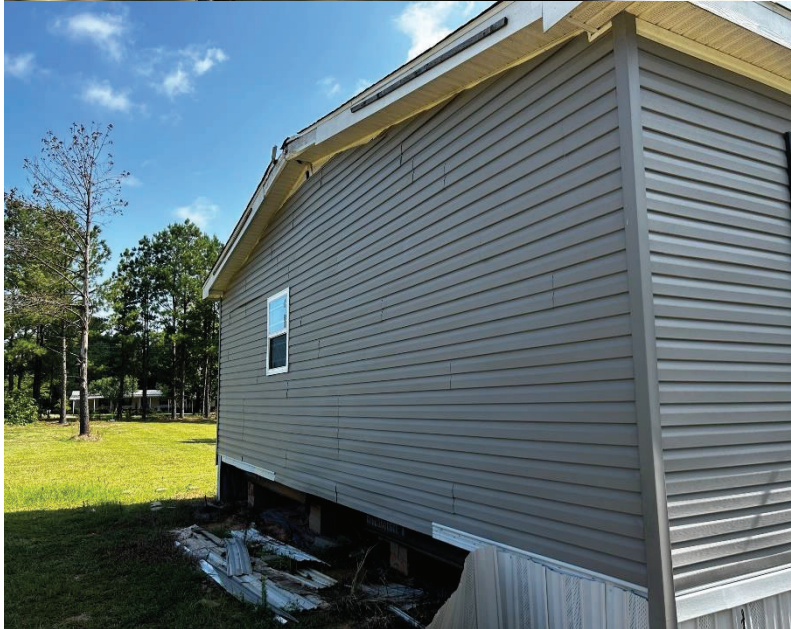
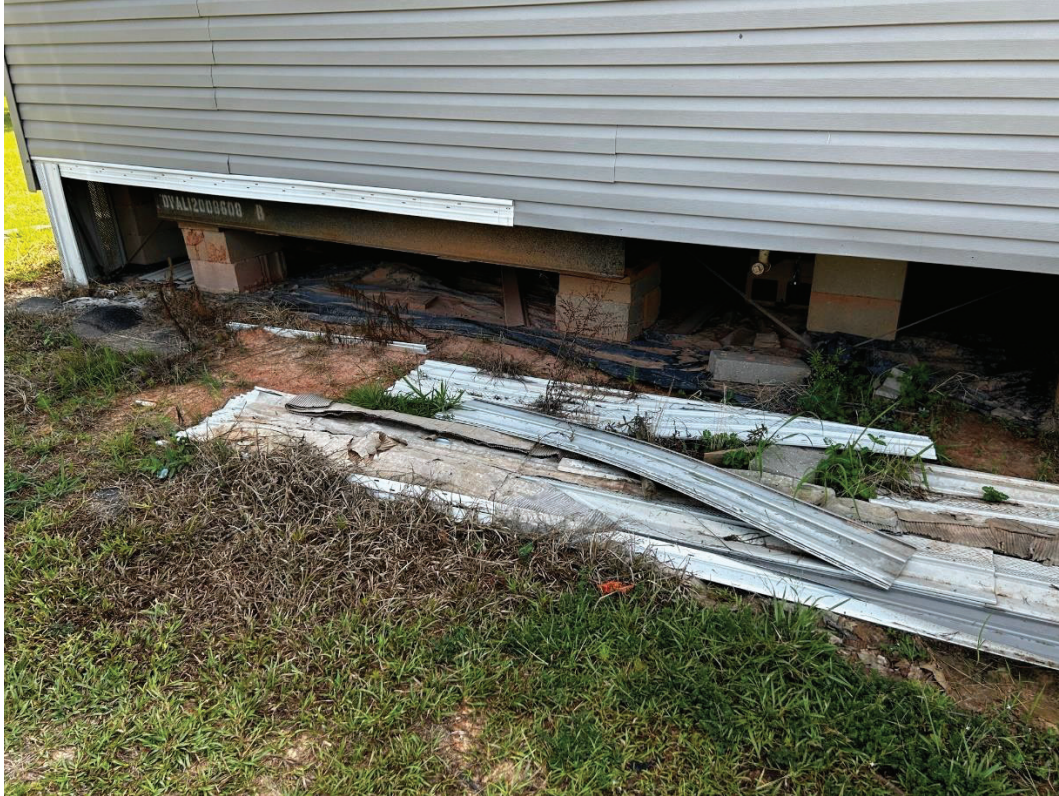
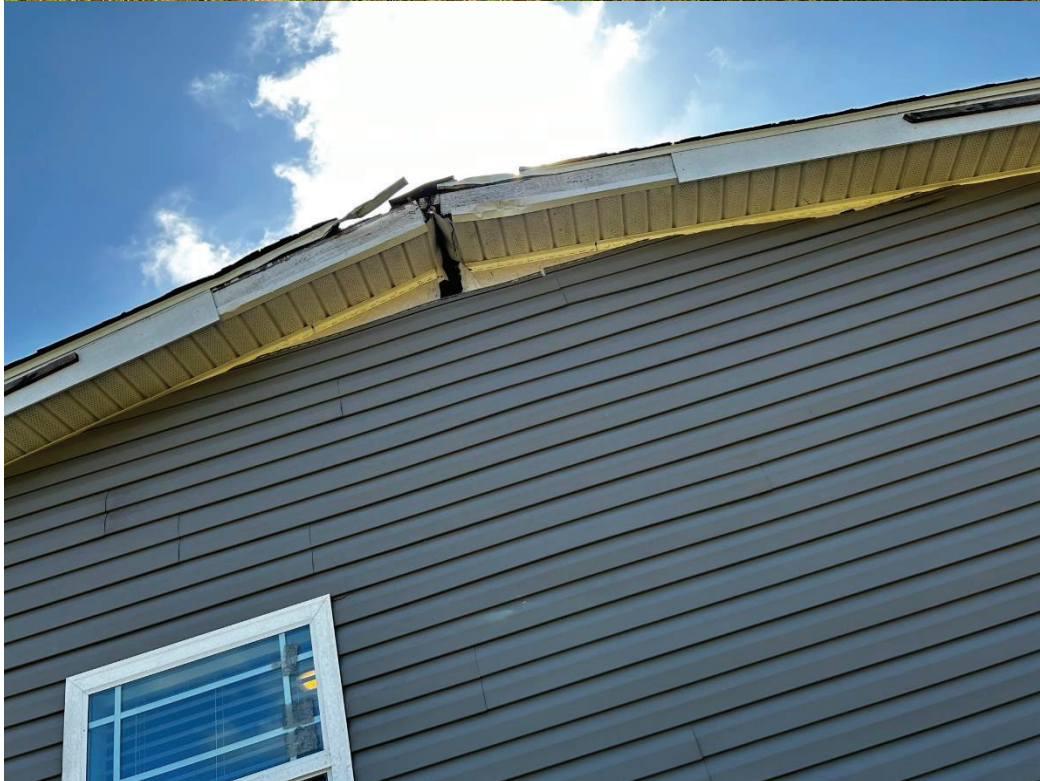
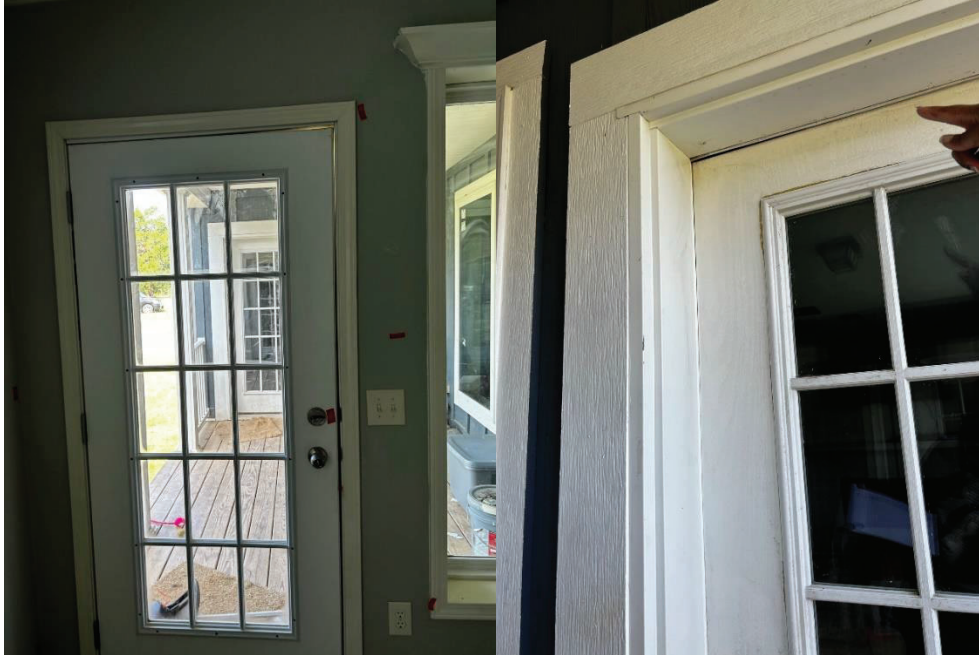
Breaches to the Outside throughout the home

- As far as “breaches to the outside” from the home these are the only identifiable photographs of alleged issues that could arguably meet that definition as observed at the inspection and identified by your clients. As for the end of the home with skirting removed, it is our position that your clients had the skirting removed and the trim and siding at the top of the home removed in order to have someone look at it or to perform attempted repairs of the alleged issues. Your clients stated that a contractor performed work on the exterior of the home at the marriage line. Furthermore, this could potentially be a manufacturing issue if the home was not framed properly at the factory, resulting in gapping between the halves. Since there was no visible gap at the floor in this same position, that seems to be the case. The exterior door on the back porch had a gap at the top corner where light was visible. This issue appears to just need a slight adjustment to level out the door in the frame. There were no other “breaches to the outside” visible at the inspection.

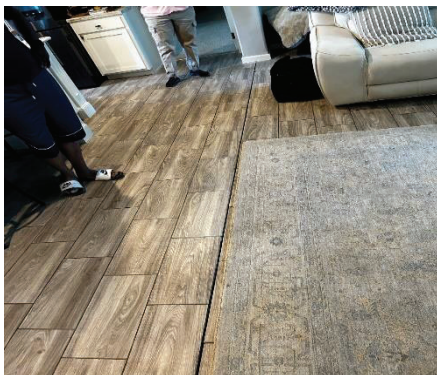
The 1 ½ inch gap in the floor is covered with stripping.

- At the inspection and as shown above, the marriage line of the home did not have any “stripping” present. The initial demand we received that indicated that there was “stripping” present at some point. Was the transition bar removed by your clients prior to the inspection? If not, that piece should be acquired through request to the manufacturer. Furthermore, based on how the flooring is laid, this home never was equipped with a seamless floor as alleged. The gap in the floor is typical for this home and should be covered by a transition bar (referred to as stripping in the demand), per industry standards.

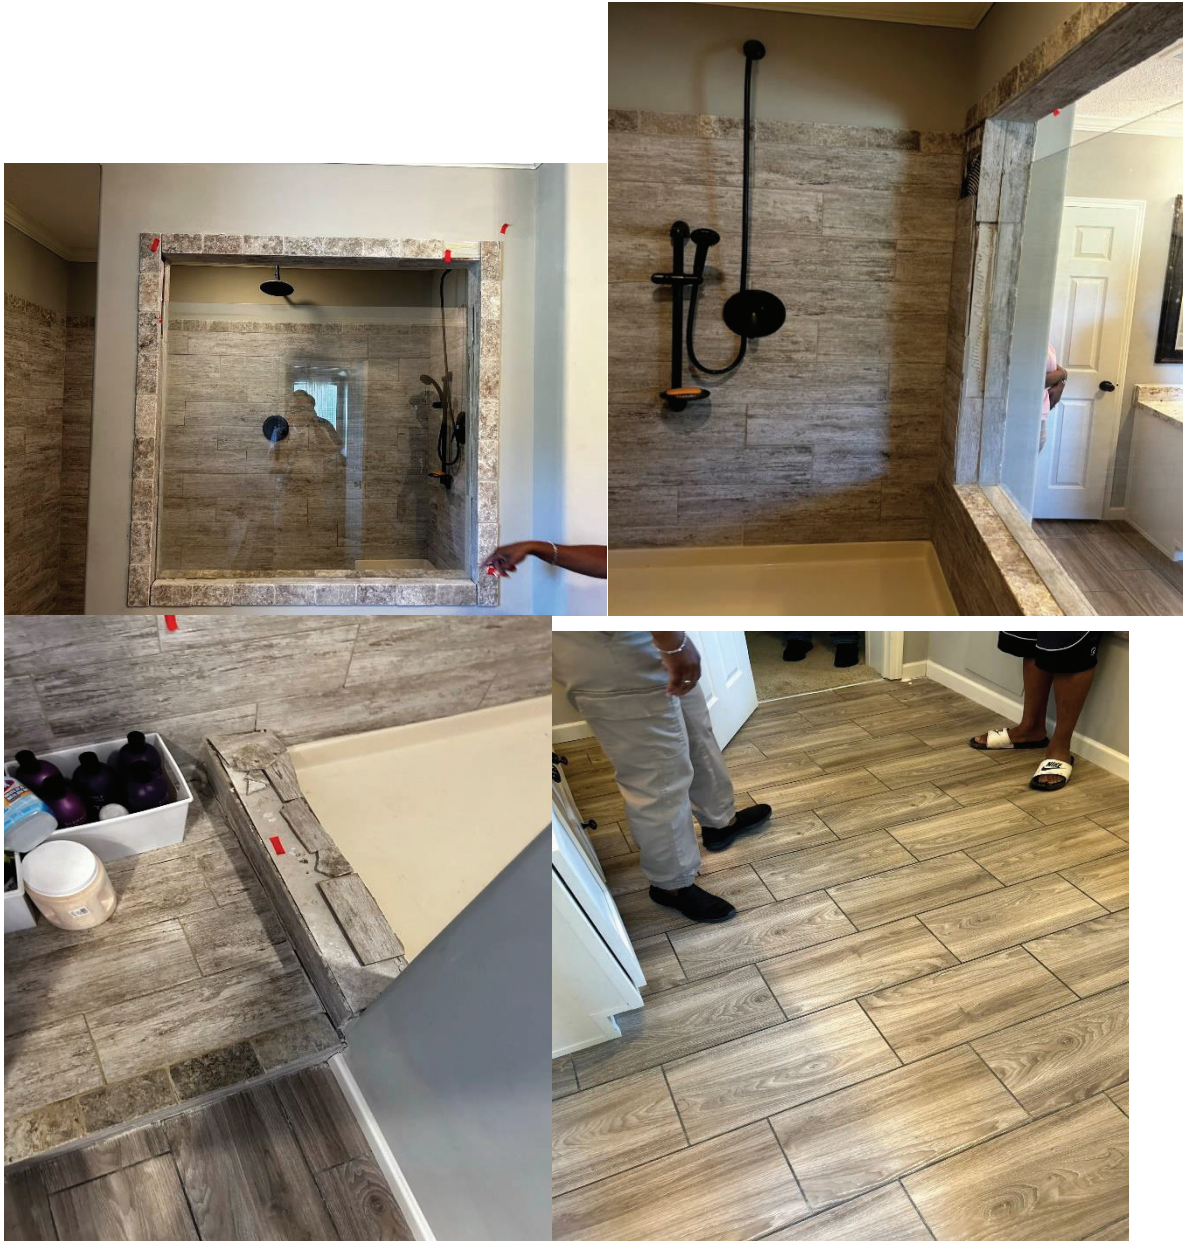
The master bathroom has missing tile and a sinking floor.

- Missing tiles were observed in the bathroom. The missing tile in the bathroom is a manufacturing issue. There did not seem to be any apparent issues with the floor. A report or expert opinion would be needed to support this contention. With any conventional foundation, variations in the floor between support joists is a normal occurrence and does not reflect a foundation or structural problem. It is worth noting here that your clients did construct the pad or had their own contractor construct the pad in this home, so the dirt work company would need to be looked to for any problems with the foundation or pad of the home.

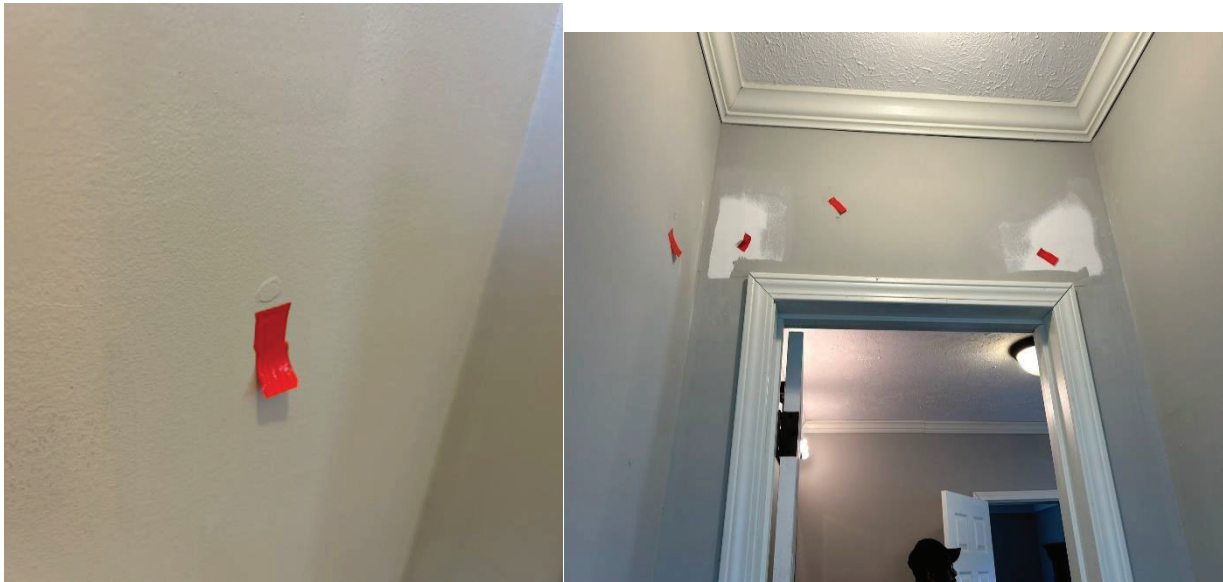
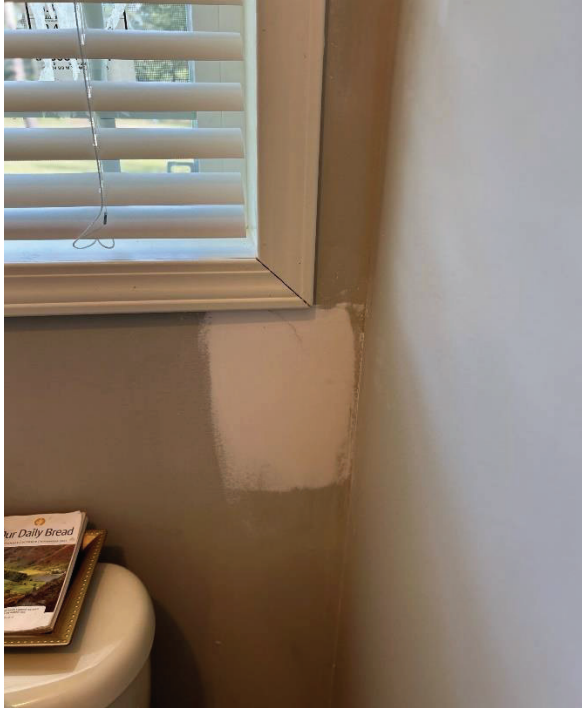
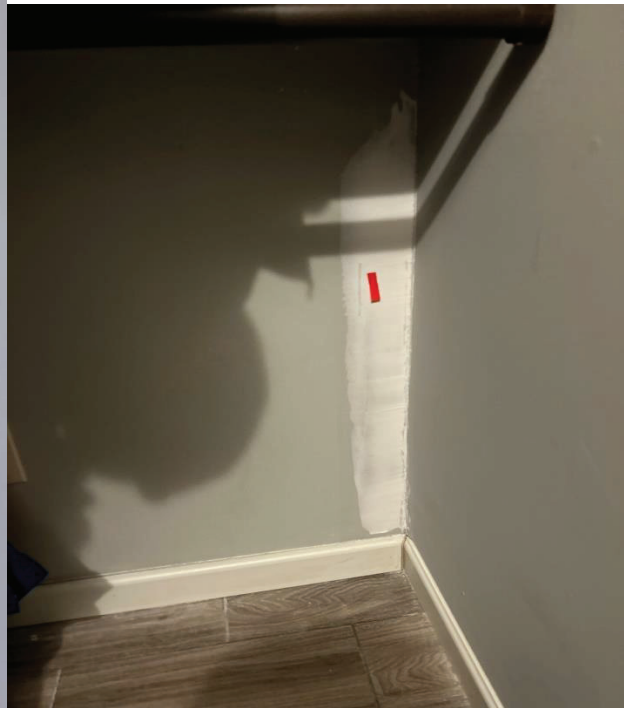
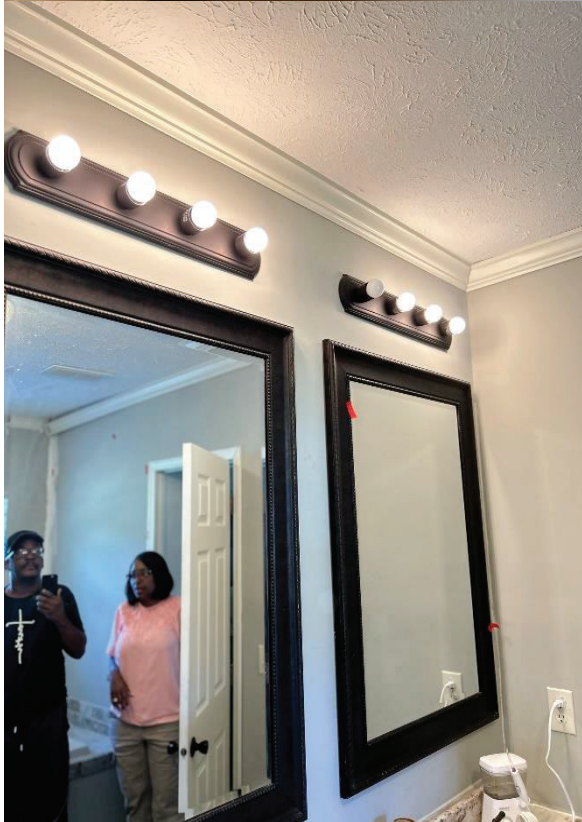
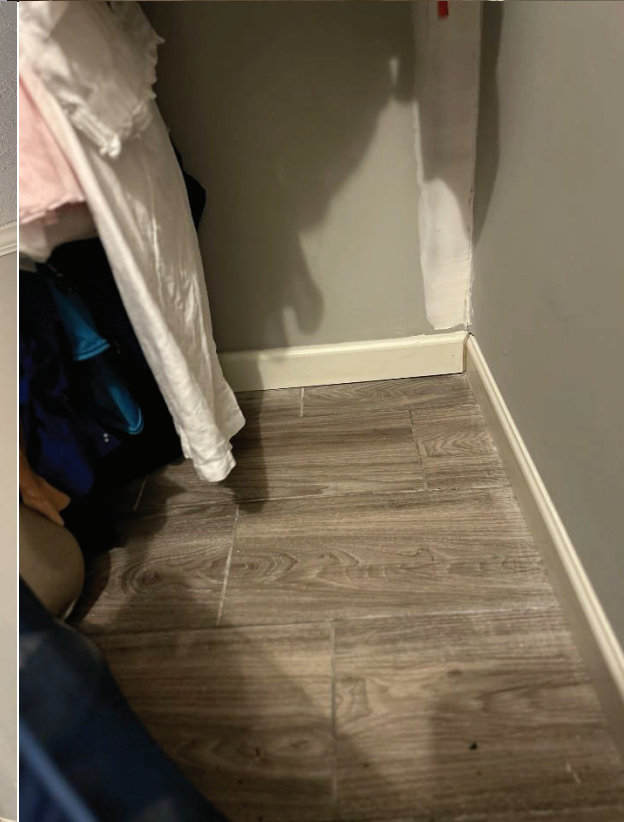
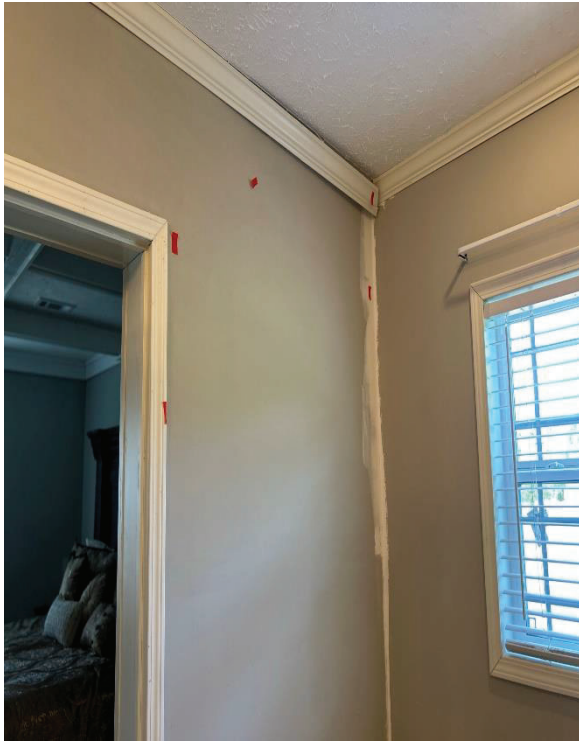
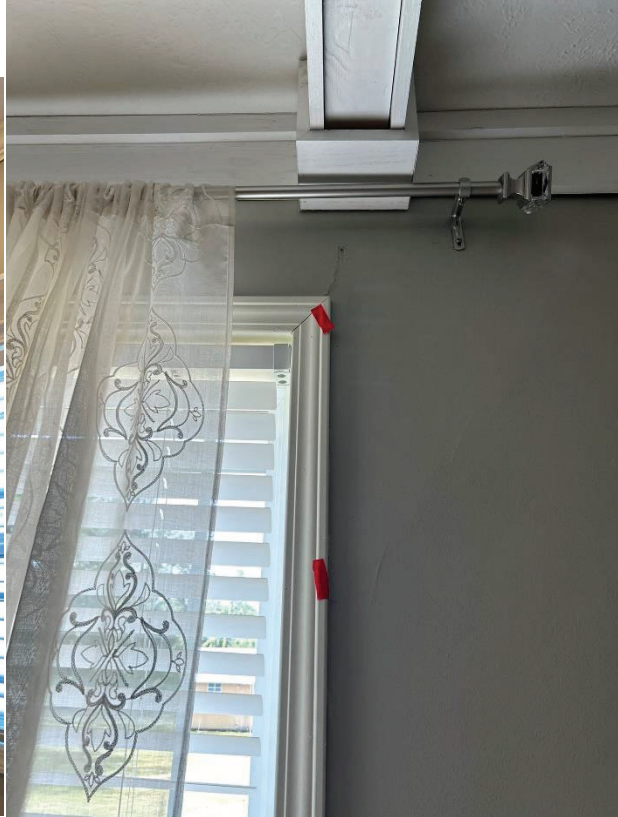
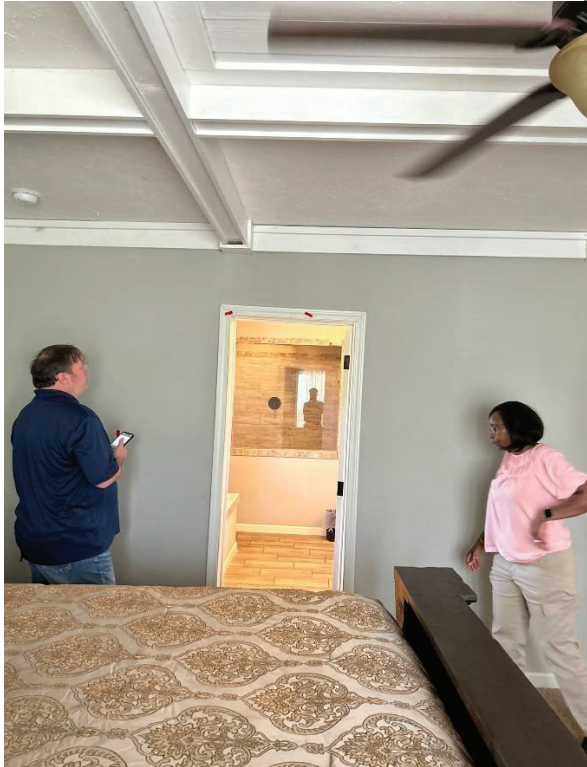
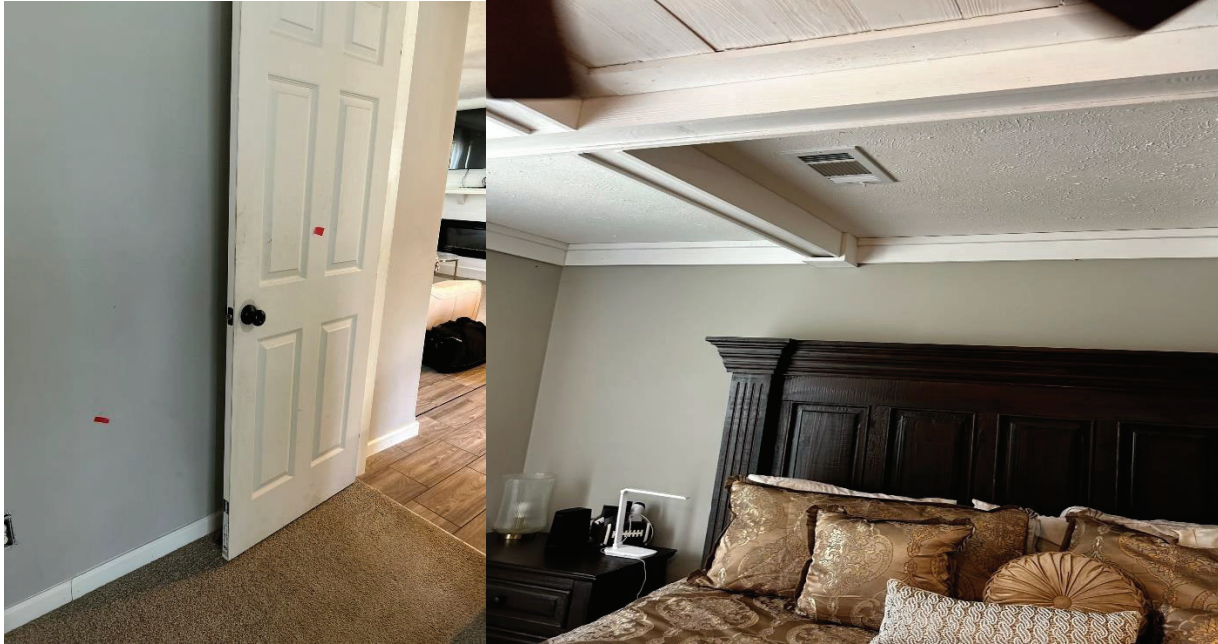
The master bedroom and bathroom have uneven walls, fixtures that don't work, an uneven ceiling and multiple other issues.

- No uneven walls or ceilings were observed during the inspection, but if this claim is substantiated, it would be a manufacturing issue. Any unfinished trim or unfinished paint was in the process of being completed by the trim out crews and can still be finished, by Regional's contractors or a contractor as hired by your clients. Cracks were observed in a few places, but nothing to indicate any structural defects. Your client stated that the door to the master bedroom was "used". It just appeared to have smudges and dirt on it which could be cleaned off or painted over. One bulb was not working over the master bathroom sink and your clients reported replacing same but it still did not work. Your client reported issues with the ceiling and trim around the master bath entry. To the extent these issues are cosmetic, they would have been finished by my client during the trim out portion of the job if your client would have allowed them enough time to complete same. If there are any structural issues with the walls and ceiling, that would be a claim to make against the manufacturer.

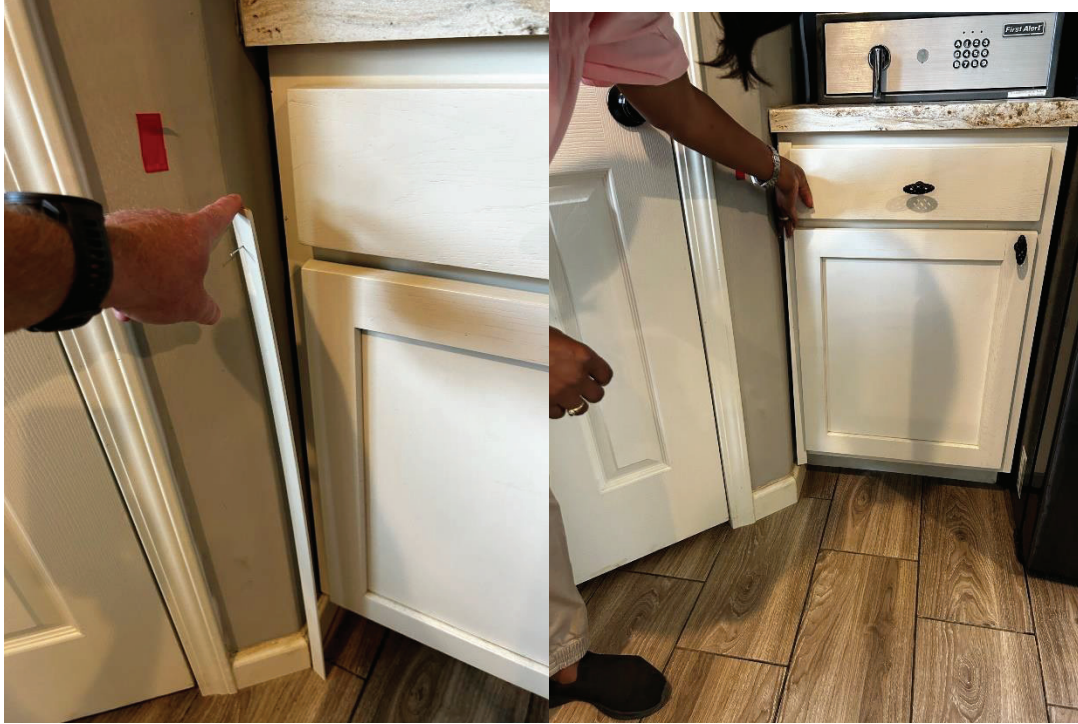
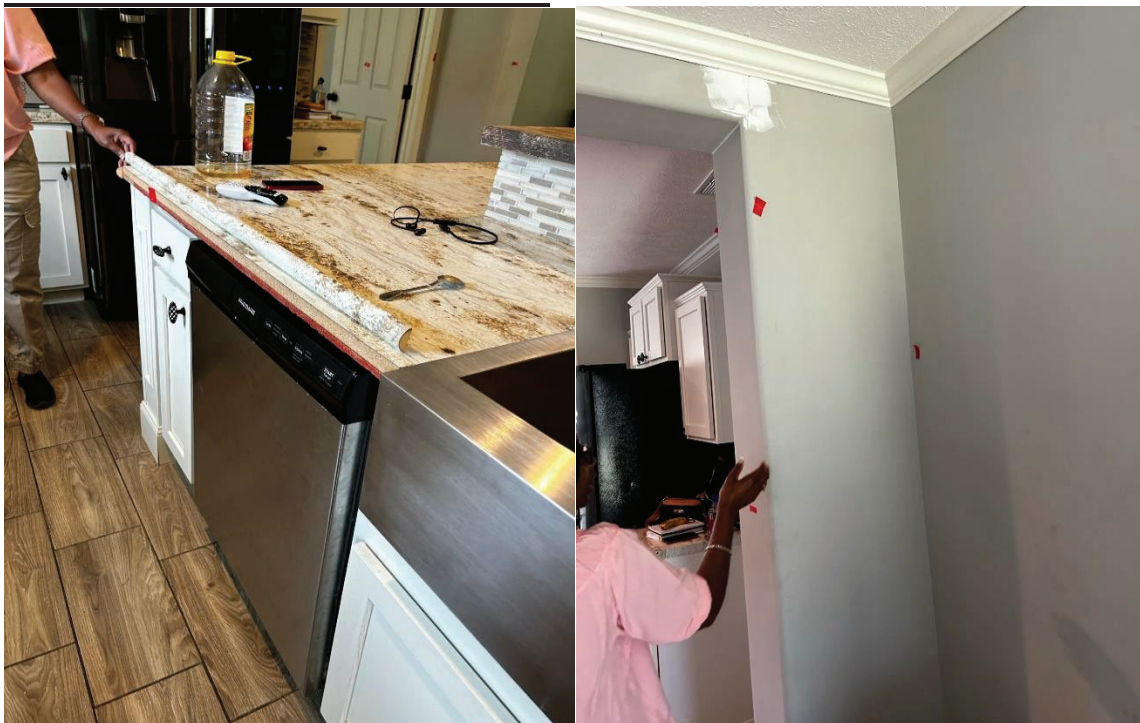
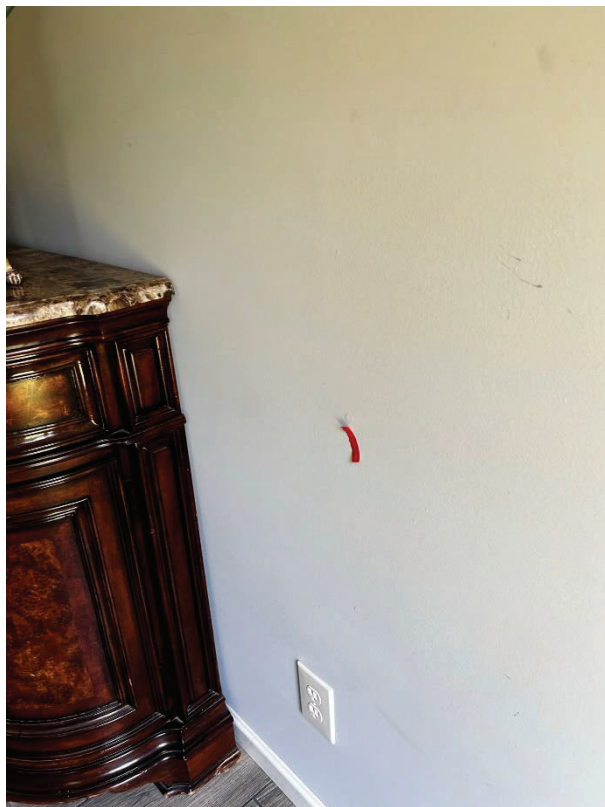
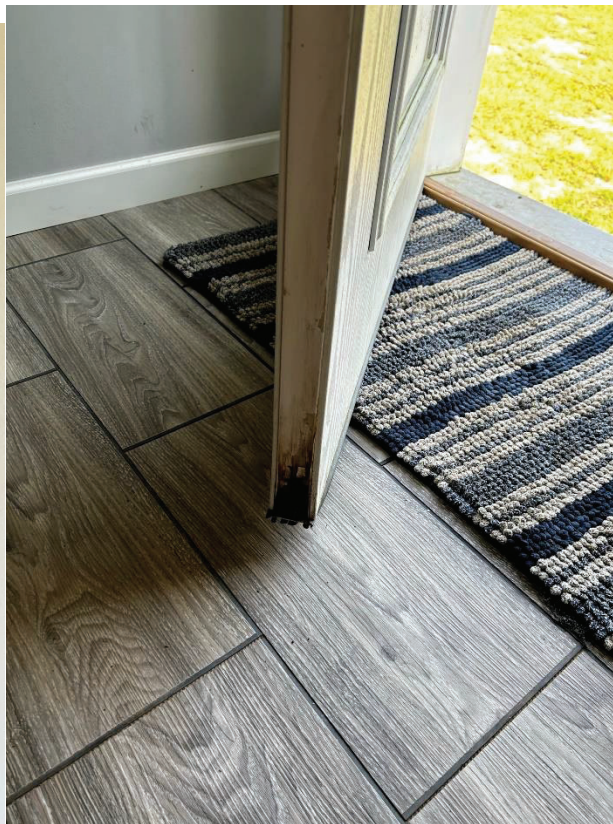
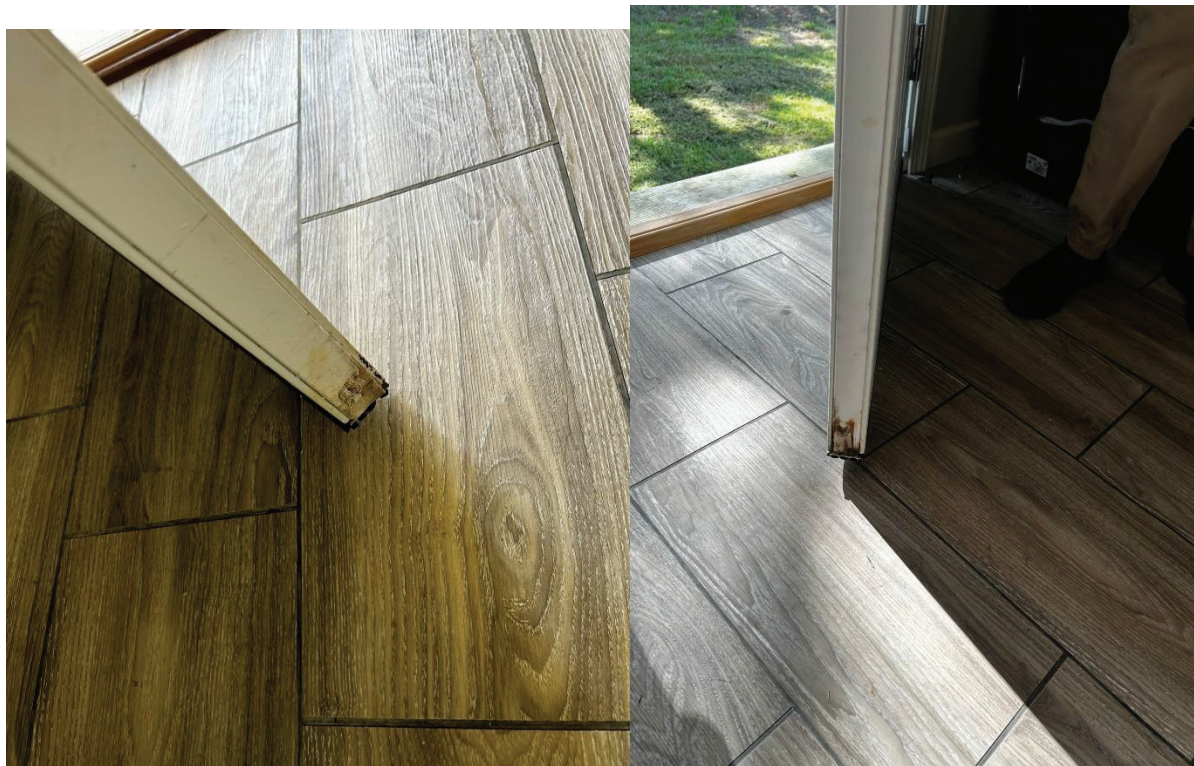
The kitchen light fixture has fallen twice. The exterior doors are either hung where they don't close properly, or they are rotting.

- In the kitchen/living room, the light was attached and your clients did not report any continuing issues about same during the inspection. If there still exists an issue with the light, that would be a manufacturing issue as well. Your clients pointed out some issues with trim and countertops in the kitchen as shown in photographs. These would be manufacturing issues as well. Your clients also reported that the microwave turned on, but did not heat up her food. This would be an issue with the appliance manufacturer and whatever warranty, if any, came with it. Your clients reported a hairline crack on the ceiling which appeared to have been repaired, but not painted. There did not seem to be any further problems with the area, so a fresh coat of paint and or some joint compound would resolve same. Your clients also reported that the entry door was rotting at the base and the same issues with the other exterior doors. This would be an issue for the manufacturer, as the exterior doors came installed on the home from the factory.

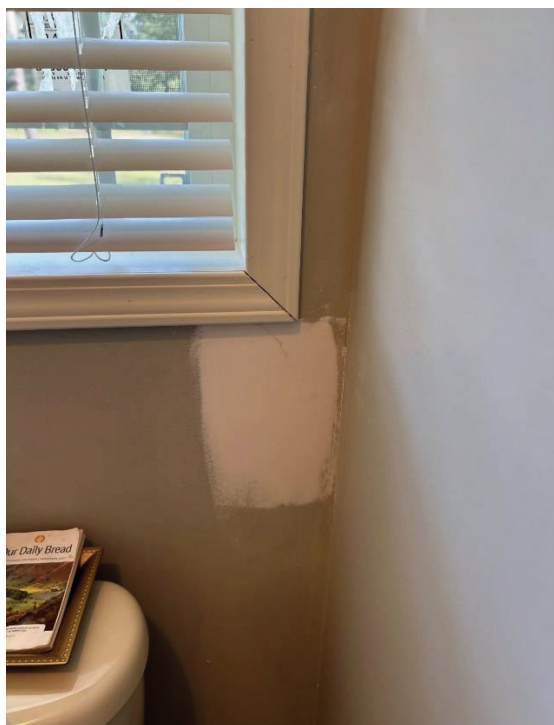
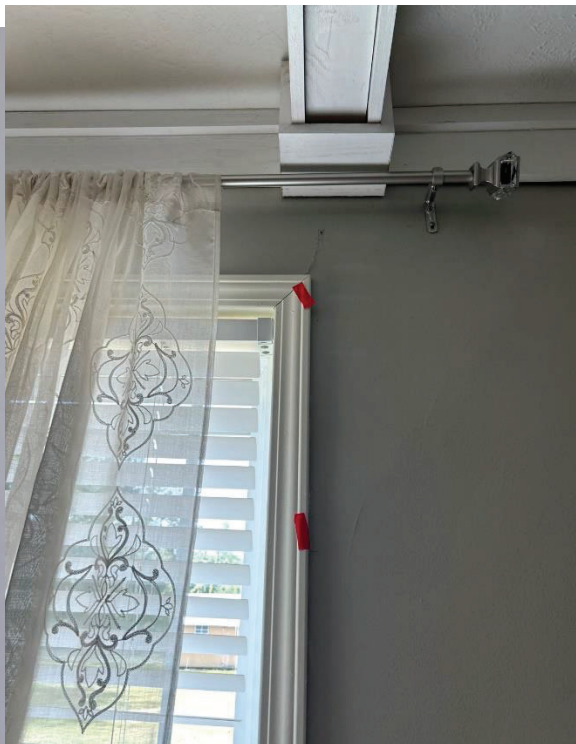
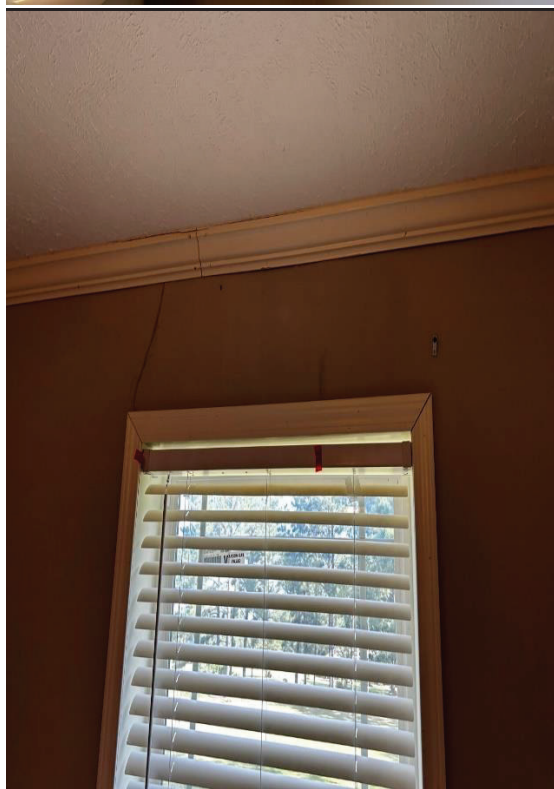
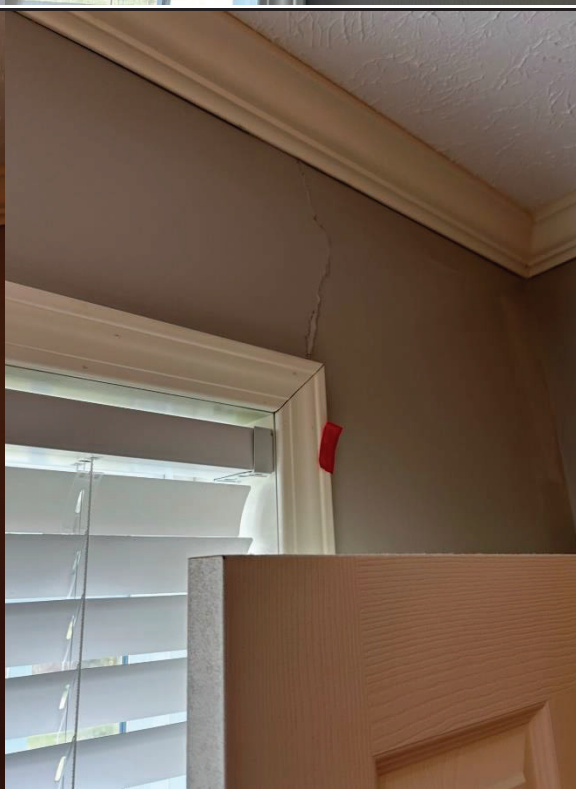
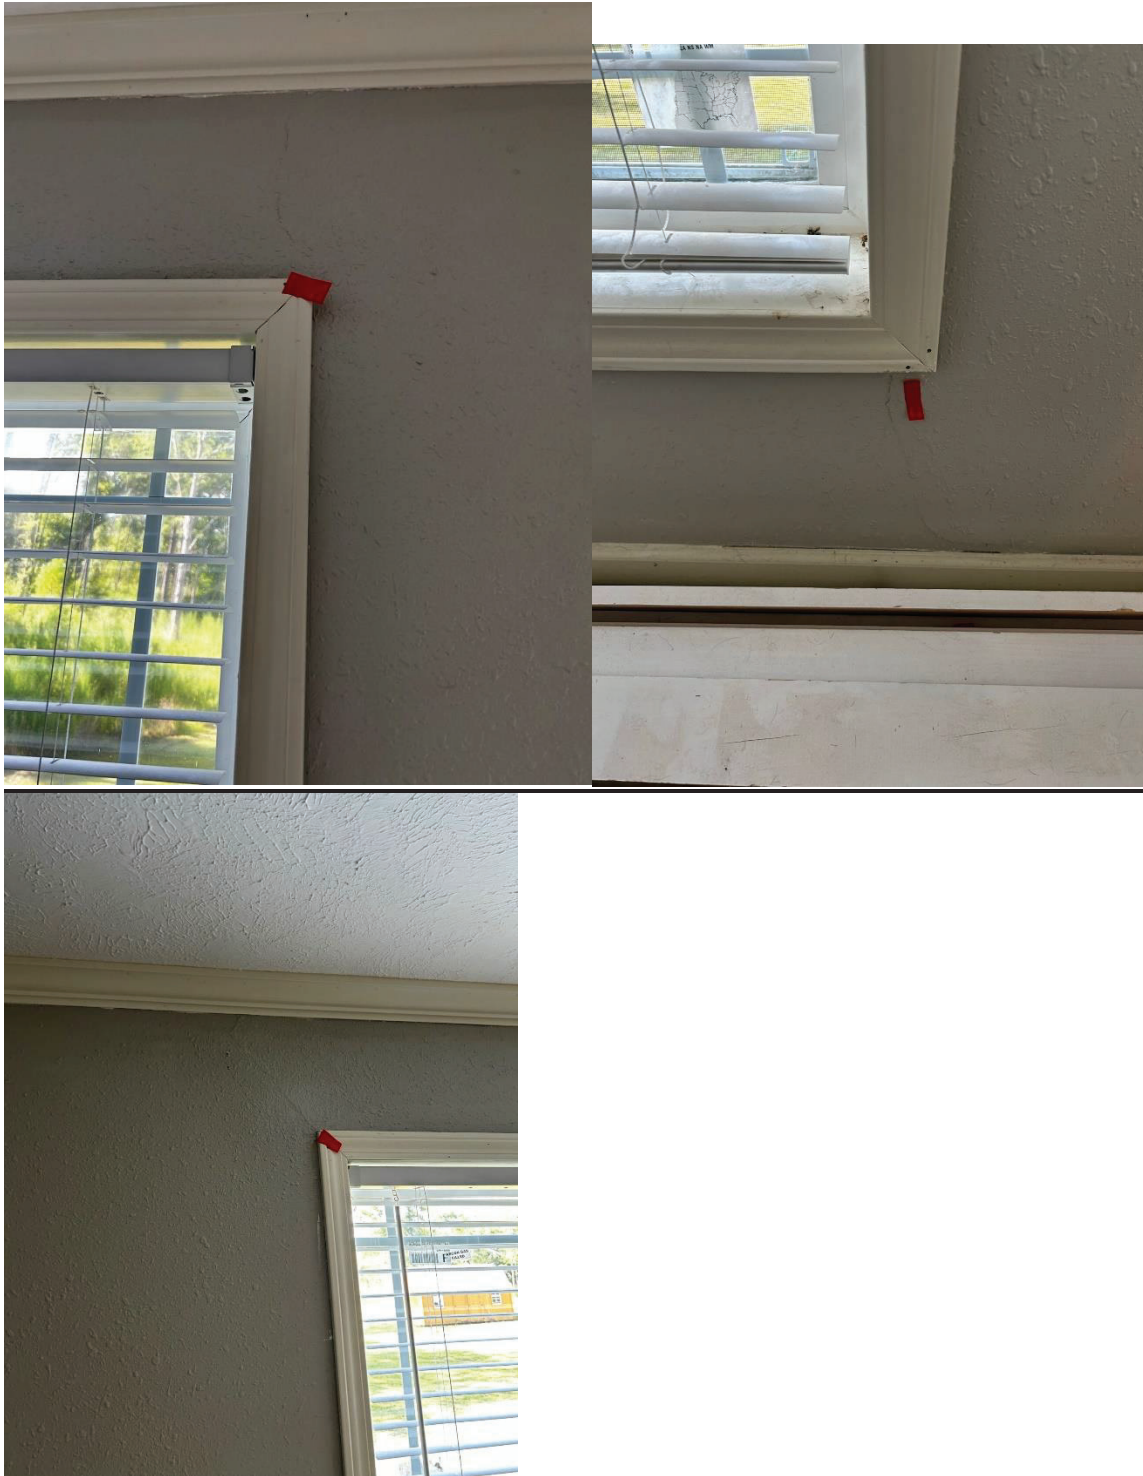
Windows with cracks

- Cracks in sheetrock near windows is expected from the transport and setup of a manufactured home. The trim crews were in the process of repairing the cosmetic issues with the home, and these issues just need some cosmetic repair. As cited throughout this response, any foundation issues will need to be substantiated by an expert in order to

determine the cause of said issues, whether it is due to the manufacturer, the dirt pad, the set up and installation crew, or otherwise.

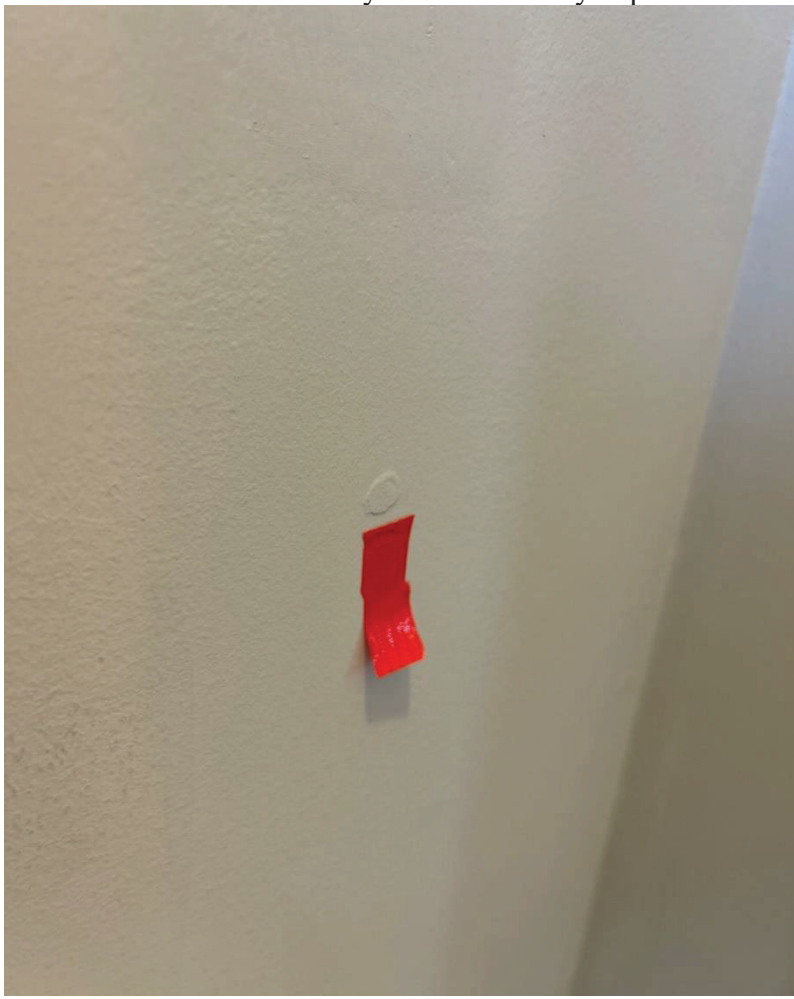
- There were no nail holes observed in the walls, only raised places where nails/screws were apparently backing out of the wall. Any nails backing out of the sheetrock would be a manufacturing issue. The trim was not finished in multiple places, leaving nail holes unfilled and unfinished on the trim. When your client notified Regional to cease the work due to the dispute, this work was not completed. However, the trim out can be completed and these issues would easily be addressed by a qualified contractor.

**Raised nail head*

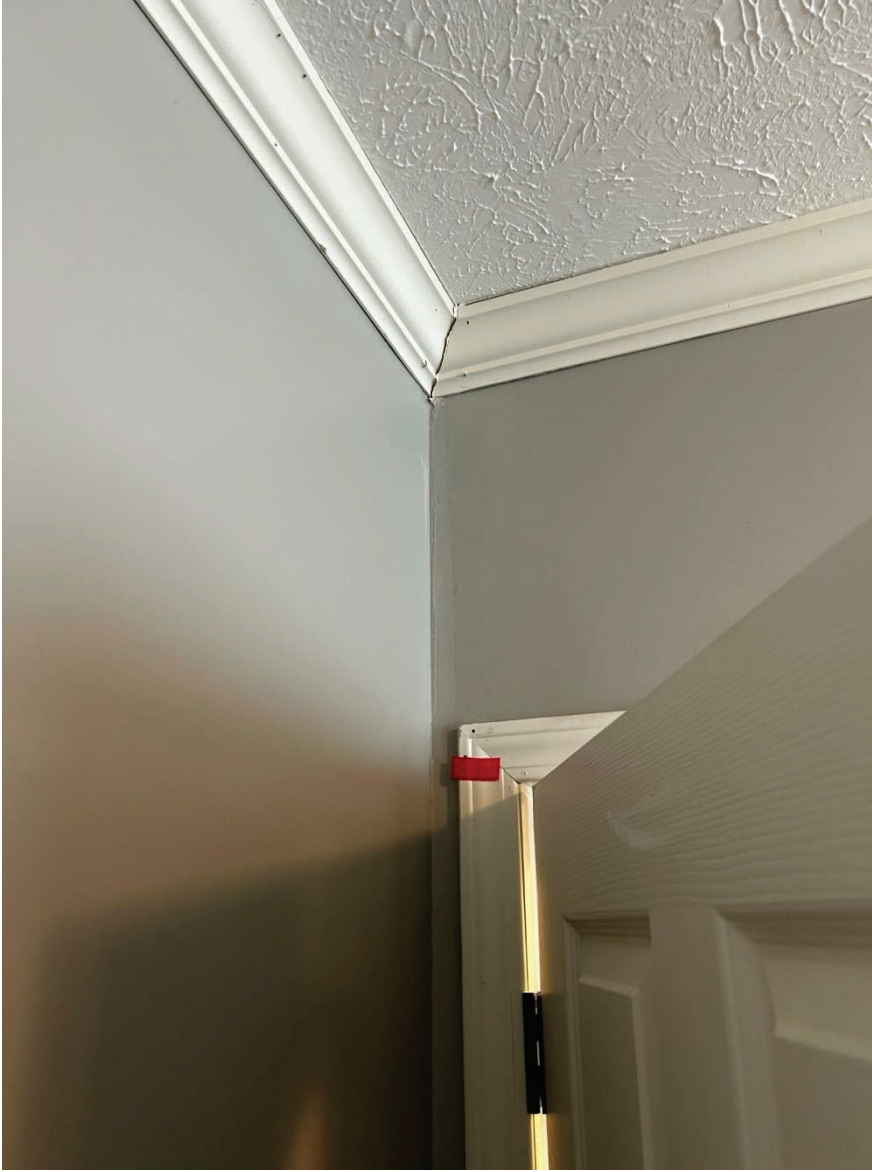
** unfinished trim*

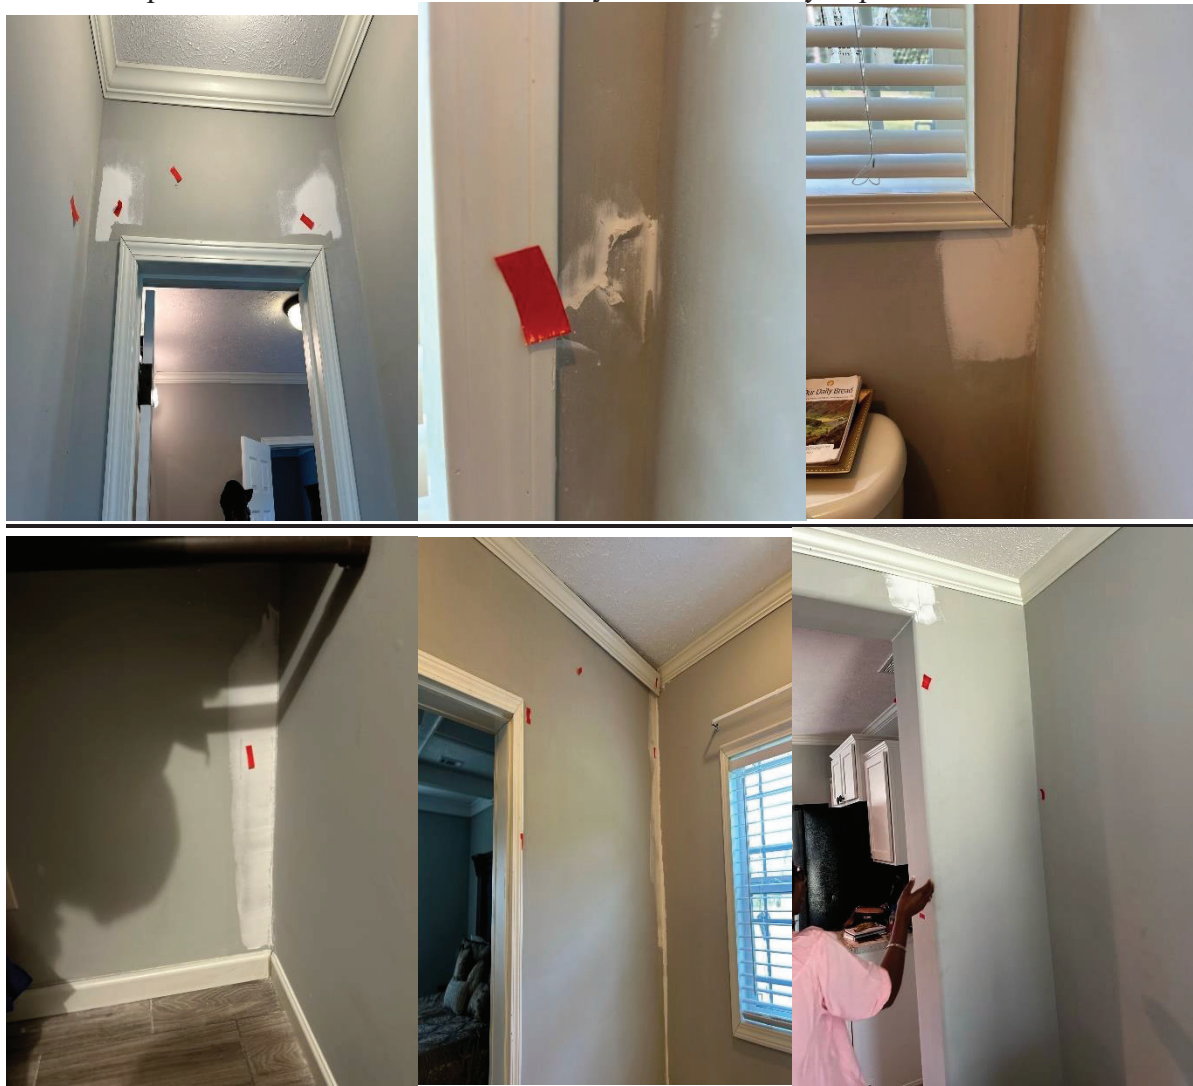
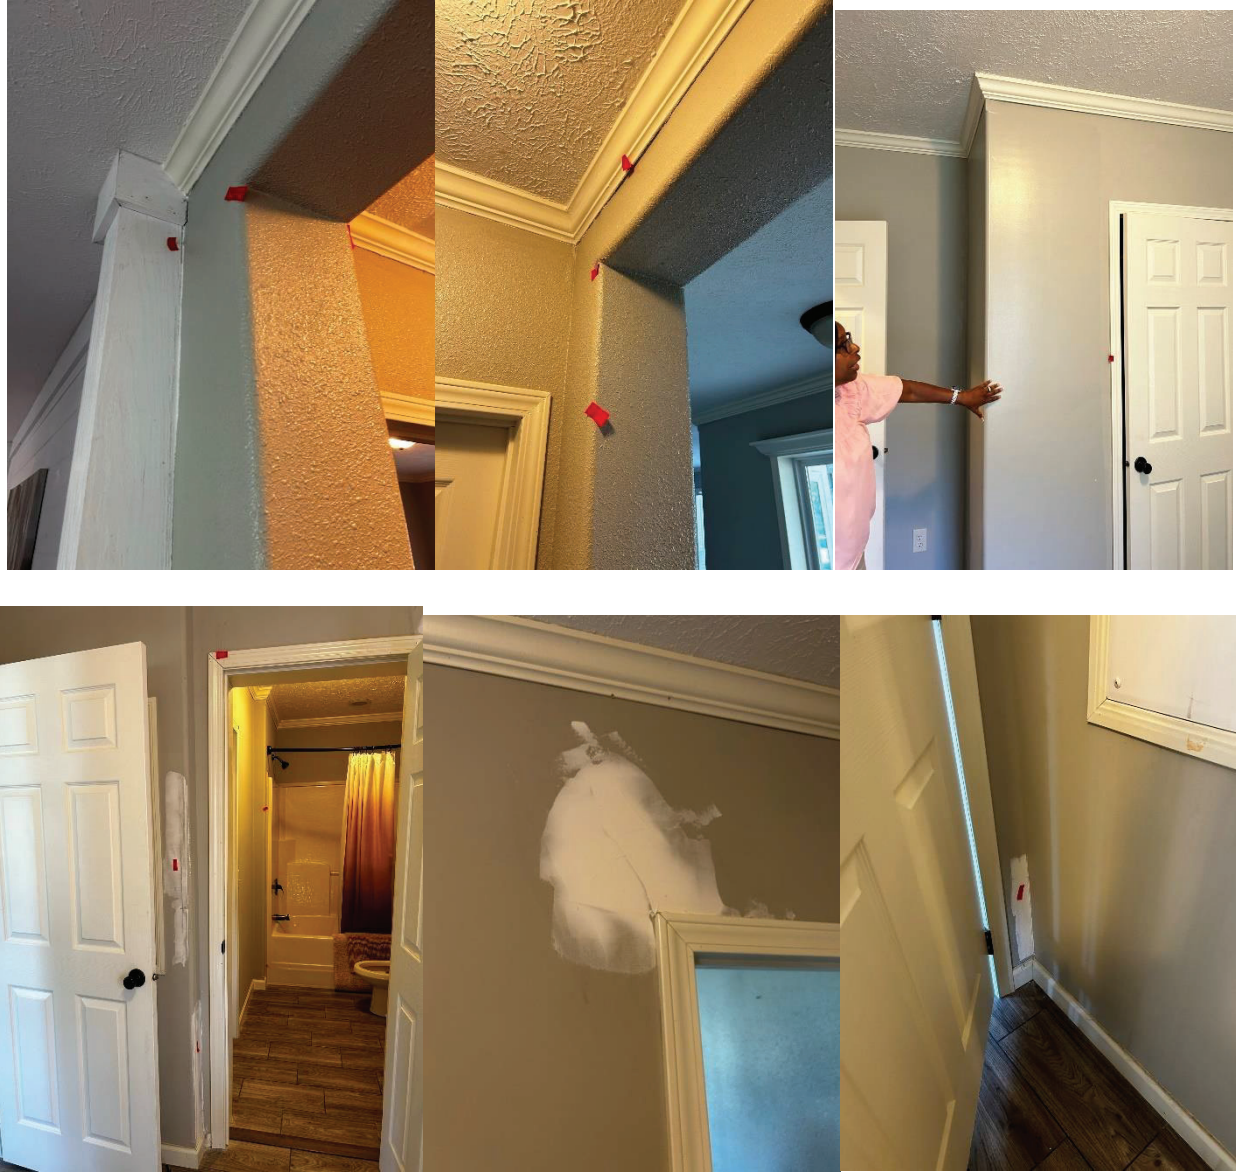
There is sheetrock work that has not been completed.

- There were several instances in every room where painting/sheetrock was not completed. Regional's position is that this is due to your clients instructing McComb Home Center employees not to come back to the property before the trim-out was complete. The customers were also not happy about some textured painting done on the walls in one hallway as it was not uniform with the rest of the house. There was also one bedroom that

was painted partly with a high gloss paint and partly a flat paint. However, the trim out can be completed and these issues would easily be addressed by a qualified contractor.
